# Evaluation of the performance of self-healing concrete at small and large scale under laboratory conditions

**Keywords:** self-healing, concrete, microscopy, corrosion, monitoring

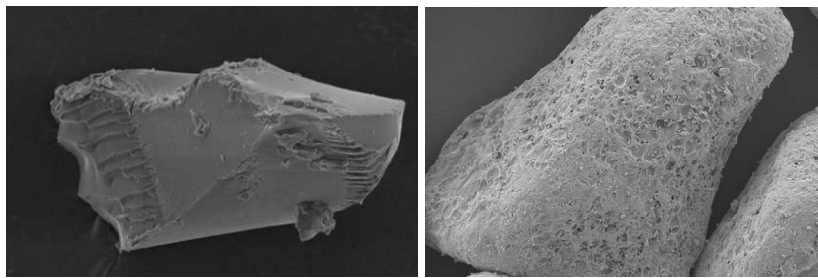
SEM images of an uncoated and coated SAP particle are shown in Figure 1. Very few holes can be detected in the coating and some agglomeration of particles occurred. Particle size analysis showed that the  $d_{50}$  increased up to  $467 \mu\text{m}$  by coating of the SAP particles.

Figure 1. Uncoated (left) and coated (right) SAP particle.

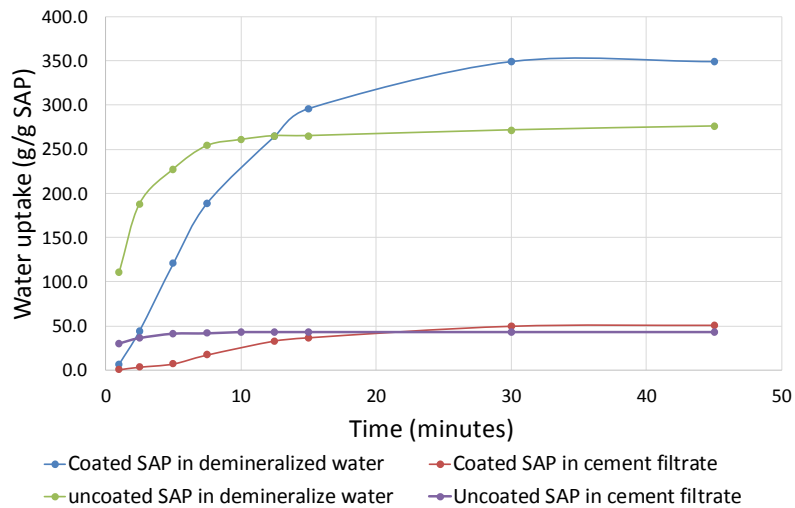
In order to determine the extent to which the swelling can be delayed by the coating, an additional test was performed. The swelling rate was determined by measuring the volume change of the swollen SAP in the different solutions at regular time intervals [2]. The results, presented in Figure 2, show that the absorption of water is slower for the coated SAPs. However, even within the first 10 minutes, water uptake could not be completely prevented by the coating. After 10-15 minutes, coated SAPs absorbed as much water as uncoated SAPs.

**Figure 2. Swelling rate of uncoated and coated SAPs.**

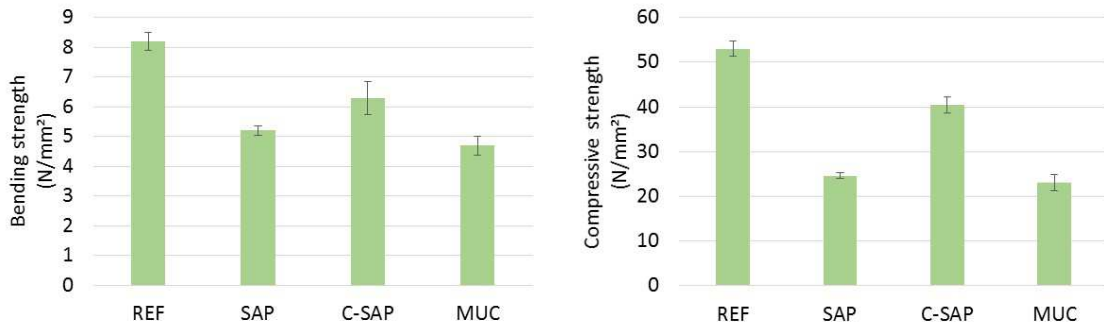
mechanical properties of the mortar. As can be seen in Figure 3, a quite high strength reduction is obtained, but the dosage of healing agents is also quite high in the mortars (1 wt% relative to the cement content). For uncoated SAPs, the bending and compressive strength decrease respectively with 37% and 54% compared to the values for the reference mix. With coated SAPs, the reduction is less (respectively 23% and 24%). This can be due to the coating, but also due to the lower water content of the mixes with coated SAP (no extra water was added, as would be the ideal case when the coating is completely impermeable and not rupturing during the preparation phase). Addition of MUC and urea cause the largest effect on the strength properties (43% and 56% reduction respectively for the bending and compressive strength). We expect, however, that addition of comparable dosages of healing agent (relative to the cement content) in concrete will not affect the mechanical properties to such a large extent.

**Figure 3.** Effect of the addition of uncoated / coated SAP and MUC on the mechanical properties of mortar.

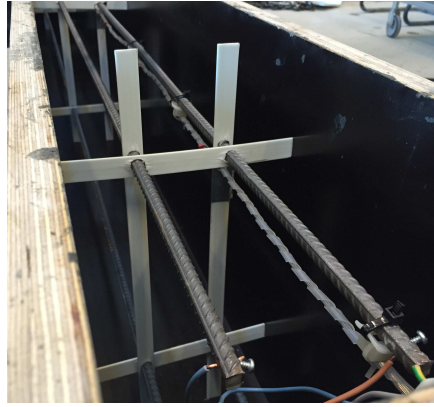
**Design of the beams, including the installation of sensors.** Concrete beams with dimensions 2500x400x200 mm were cast of each of the three mix designs. The beams were reinforced with four 10 mm ribbed steel bars with a cover of 55 mm (4).

**Figure 4.** Formwork with rebars and MuRE sensor installed below one rebar.

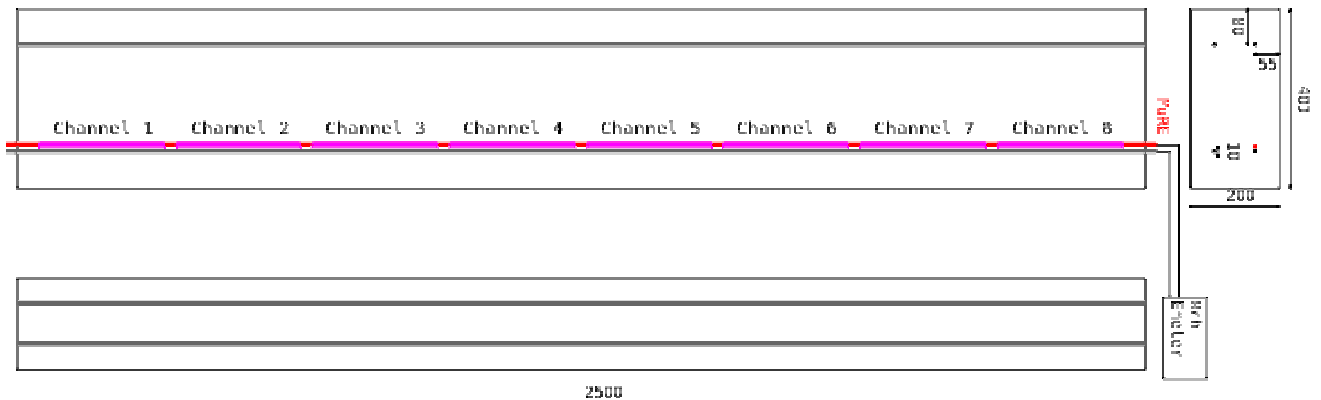
A wireless monitoring system was installed and the beams were instrumented with sensors for continuous monitoring. The self-healing efficiency was indirectly monitored with electrometers attached to the MuRE (Multi Reference Electrode) sensors [8] which were embedded into the beams in proximity to the reinforcement (Figure 5). This allowed to monitor the electric potential within the concrete which is affected by electrochemical processes such as reinforcement corrosion. In case of successful self-healing, the cracks in the samples should be sealed, as such no reinforcement corrosion should be measurable in the respective areas. On the other hand, if reinforcement corrosion is detected in the area of a crack, after a supposedly healed specimen has been exposed to chloride solution, the healing was insufficient to protect the reinforcement.

**Figure 5.** Instrumentation of concrete beam with MuRE sensor (Nickel wire segments, potential measurement against reinforcement) – scale 1:10.

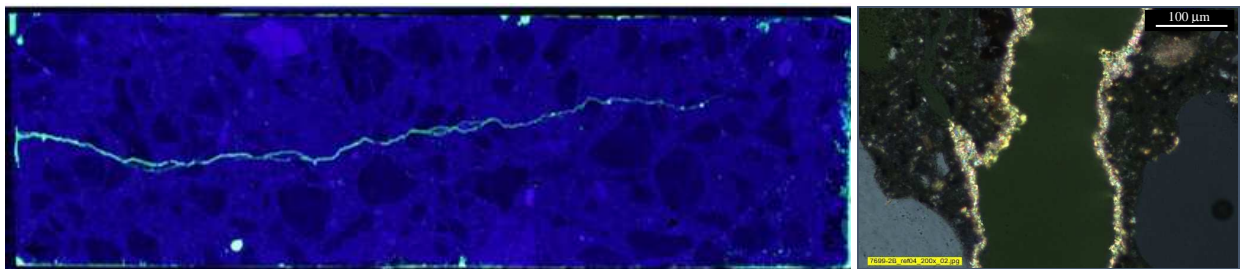
**Self-healing efficiency evaluated by visual inspection and microscopy.** The crack healing at the surface was evaluated during the cyclic water exposure period both by visual inspection and using a crack microscope. For the REF and MUC beams, no crack healing could be identified (no visual precipitation in the cracks). This was confirmed from the analysis of plane and thin sections, where the cracks appeared empty with only a thin crust of calcite formed along the crack faces (Figure 6).

**Figure 6.** Epoxy impregnated plane section of the reference concrete in UV light showing empty crack (left) and calcite precipitation along crack faces (right).

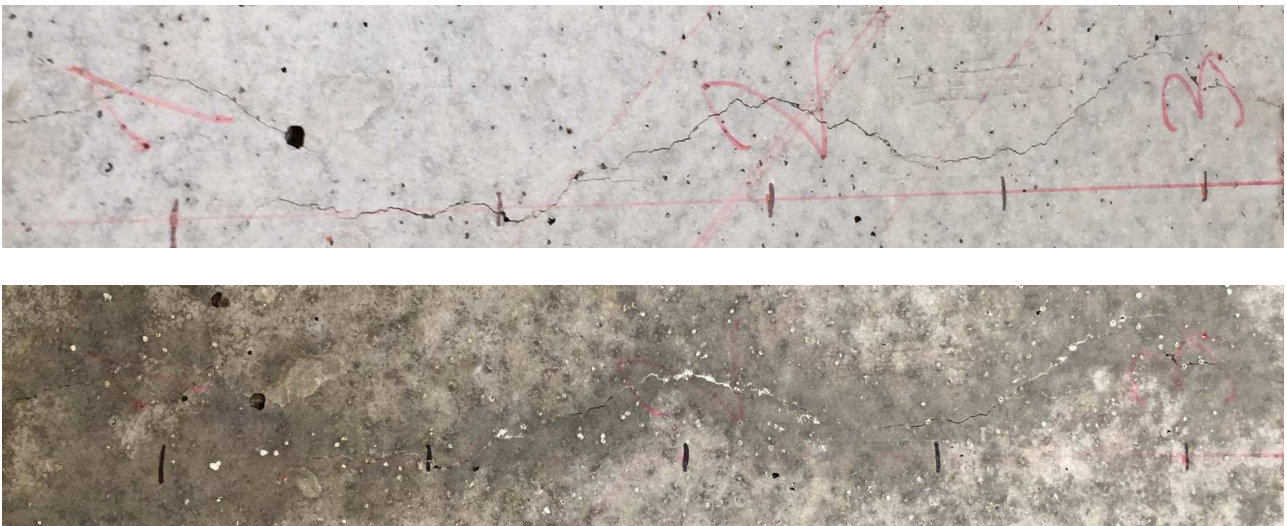
For the C-SAP beam, the smaller (0.1 and 0.2 mm) cracks seemed to be partially closed in the surface and some white precipitate could clearly be identified (Figure 7). The fact that larger cracks are not healed is not surprising. Our findings correspond quite well with the maximum crack widths which can be closed due to stimulated autogenous healing by SAPs reported in literature [11].

**Figure 7.** C-SAP beam with a 0.2 mm crack before (top) and after (bottom) 4 weeks water exposure.

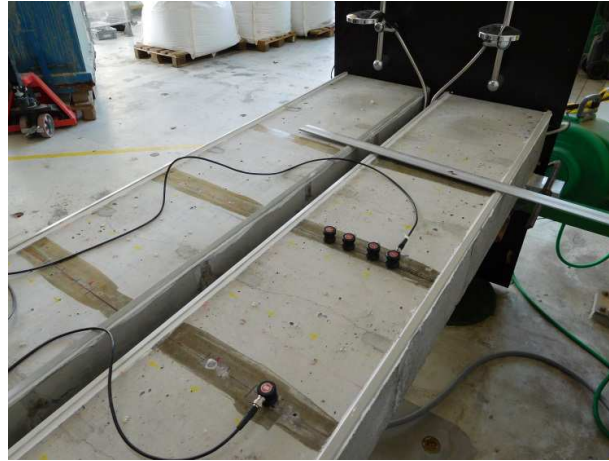
**Self-healing efficiency by ultrasonic measurements.** Known from previous studies [12], e.g. small-scale tests, the ultrasonic transmission method is useful for crack depth determination by picking the onset of the acoustic wave. In order to proof self-healing, a change of the onset time is expected due to (partial) crack closure. Therefore, single-sided ultrasonic transmission measurements at one surface (Figure 8) were conducted for crack widths from 0.4 mm to 0.6 mm during all different states (initial, cracked, healed).

Figure 8. Large-scale beams after water exposure period with installed NDT instruments.

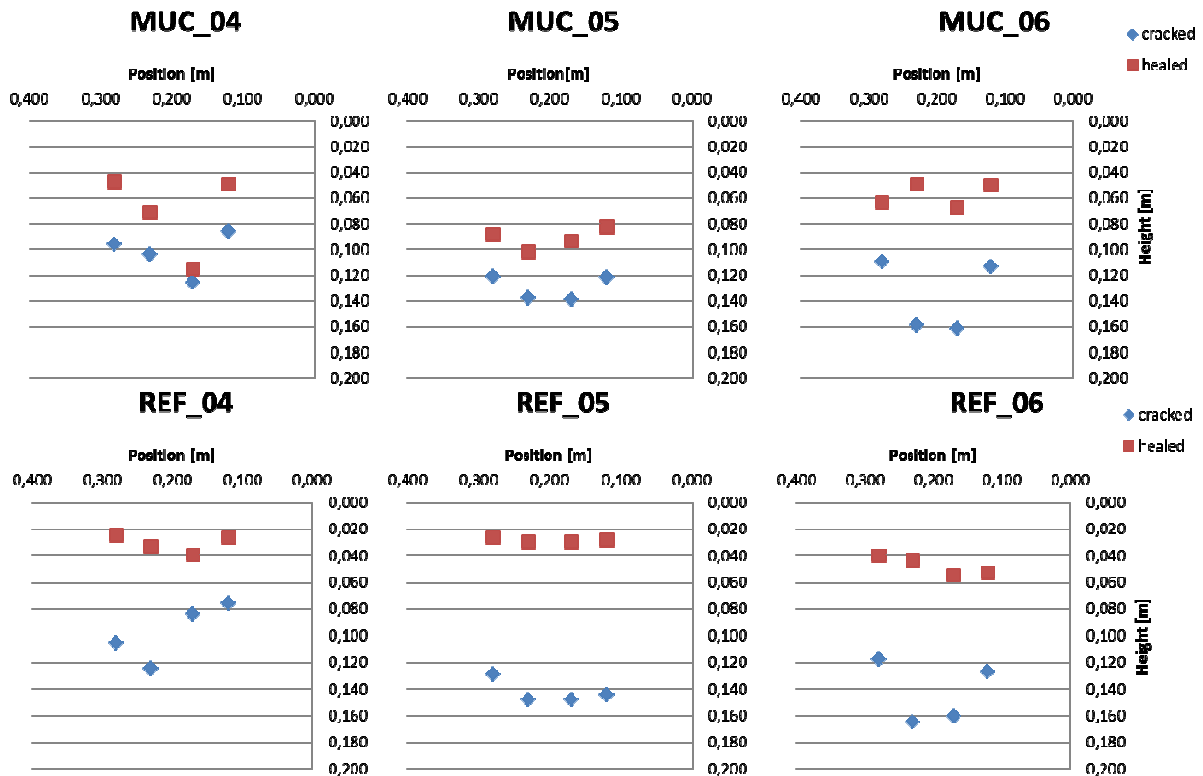
Figure 9 shows the crack depths, examined by time of flight differences of compressional waves, for the MUC and the REF beam for crack widths from 0.4 mm (MUC/REF\_04) to 0.6 mm (MUC/REF\_06).

Figure 9. Results of the crack depth examination for the MUC and REF beam by ultrasonic transmission measurements for different crack widths (0.4, 0.5, 0.6 mm). The outer measurements (Position: 0.120 m, 0.280 m) are affected by the design of the test specimen.

The crack depth is determined through the extended detour of the acoustic wave around the crack. It can be noted that with increasing crack width a larger crack depth is identified. Alternative analyses of the crack depth (e.g. visual inspections of drilled cores) confirm these results. After 6 weeks of water exposure and an additional 2 weeks of drying, crack depths vary significantly and no trend is identifiable with regard to the different crack widths as well as between the REF and MUC beams. The decrease of the crack depth after water exposure can be caused by (1) a general crack width reduction, due to shrinkage effects, movement of the specimens or (2) a creation of contact points along the crack, due to sedimentations during water exposure. Further analysis as accumulated energy or frequency content did also not suggest any indications for healing effects.
